Contract #: 04-0120F4Cty: SF/ALA Rte: 80 PM: 13.2/13.9File #: 69.28**WELDING INSPECTION REPORT****Resident Engineer:**Siegenthaler, Peter**Address:** 333 Burma Road**City:** Oakland, CA 94607**Report No:** WIR-020236**Date Inspected:** 27-Dec-2010**Project Name:** SAS Superstructure**OSM Arrival Time:** 700**Prime Contractor:** American Bridge/Fluor Enterprises, a JV**OSM Departure Time:** 1900**Contractor:** Zhenhua Port Machinery Company, Ltd (ZPMC), Changxing Island **Location:** Shanghai, China**CWI Name:** Mr.Zhu Zhong Hai.**CWI Present:** Yes No**Inspected CWI report:** Yes No N/A**Rod Oven in Use:** Yes No N/A**Electrode to specification:** Yes No N/A**Weld Procedures Followed:** Yes No N/A**Qualified Welders:** Yes No N/A**Verified Joint Fit-up:** Yes No N/A**Approved Drawings:** Yes No N/A**Approved WPS:** Yes No N/A**Delayed / Cancelled:** Yes No N/A**Bridge No:** 34-0006**Component:** Orthotropic Box Girder (OBG)**Summary of Items Observed:**

OBG TRIAL ASSEMBLY**OBG Segment 12AW~12BW**

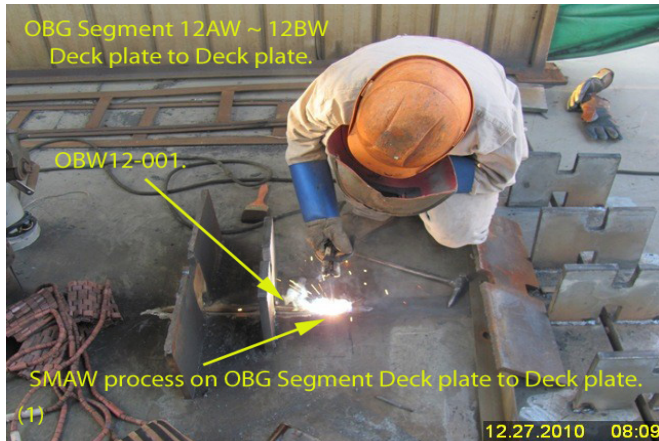
This QA Inspector observed ZPMC qualified welding personnel identified as 046709, 044551, Perform Shielded Metal Arc Welding (SMAW) on OBG segment 12AW to 12 BW Deck plate to Deck plate joint. Joint identified

as OBW12-001. ZPMC QC Identified as Zhou Peng. The welding parameters as measured using QC's calibrated instrument appeared to be in general compliance with WPS-B-P-2211-B-U2-FCM-1. For more information see below attached picture number 1.

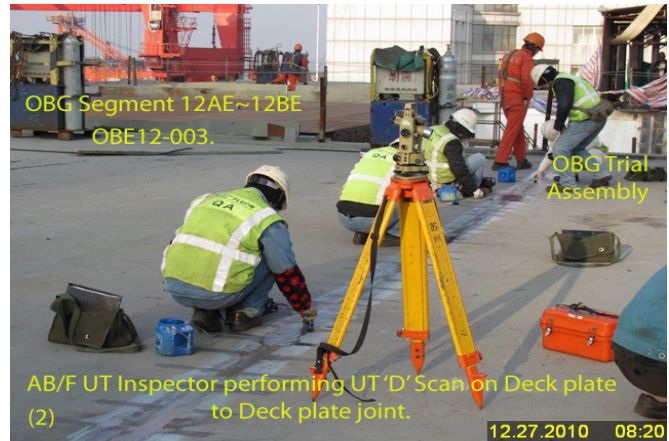
This QA Inspector observed AB/F Ultrasonic Testing Inspector, performed UT "D" scan on OBG Segment 12AE~12BE Deck plate to Deck plate joint. Joint identified as OBE12-003. For more information see below attached picture number 2.
